29. Fall from roof

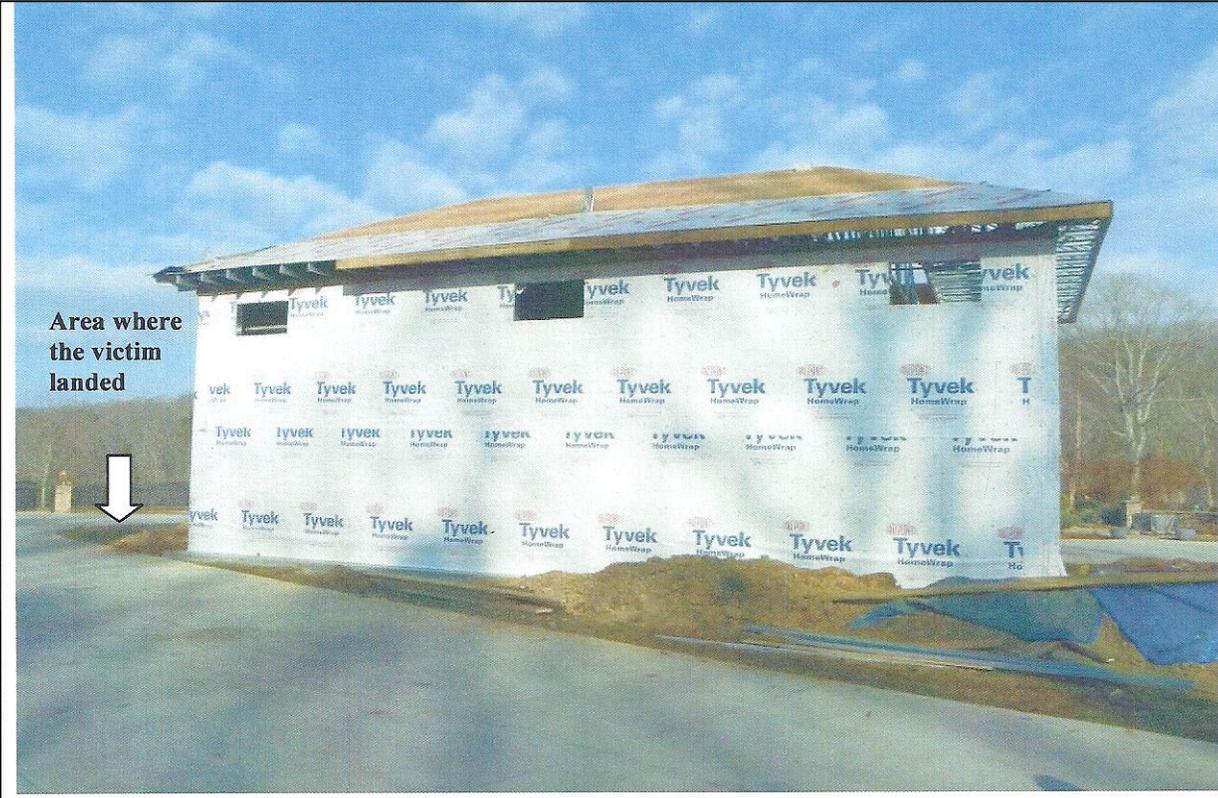
A **37-year-old** Hispanic roofer fell from a roof while performing work on a new residential garage construction. The garage was designed with a 6/12 pitch roof, plywood decking, ice and water shield, and metal seamed roofing. At the time of the incident, employees were installing plywood decking to the roof. The victim and a co-worker were standing at the top of the roof talking about the project. The victim stated that he was concerned about the employee using a circular saw to cut the plywood because he was working so close to the edge of the steep pitch roof. The victim began walking down the roof toward the co-worker at the edge of the roof, presumably to warn him about working at the edge. The circular saw the co-worker was using created a thin layer of sawdust on the roof surface. As the victim approached the co-worker, he suddenly lost his footing and started to slide. The victim grabbed the tool belt of the co-worker but could not hold on. The co-worker felt the victim release his grip on the tool belt and saw him fall over the edge of the roof. The victim fell 16 feet to the ground and his head made contact with the concrete driveway below. EMS was called and the victim was transported to a local hospital by helicopter, but his injuries were fatal.

Area where
the victim
landed
